**Flood Control Project Maintenance
Levee Inspections**
LMA District Cover Sheet
Spring 2017 Levee Inspection Results

Reclamation District No. 0544 Upper Roberts Island

Spring 2017 Levee Inspection Results

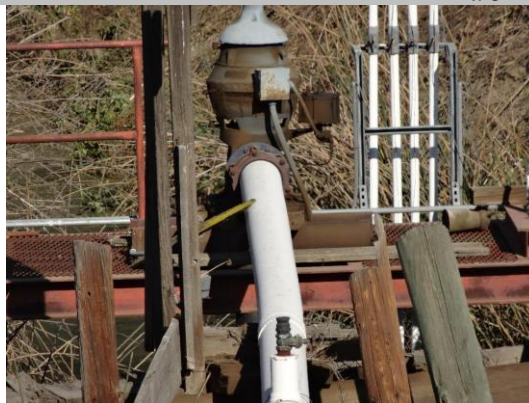
Photo 3 of 3 : UCIP_SP_2017_24908_44896.jpg

LM Start	3.20	Rating **	M	Issue No.	88 (cont)	
LM End	3.20	Issue Type +	En	Location *	WS	
Category	Supplemental			GPS Latitude/Longitude		
				Start	End	
Item	DWR UCIP Field Study			37.818824 °	37.818824 °	
				-121.359526 °	-121.359526 °	
DWR ID						
Comment Code						
Inspector Comment						
FS_ID:24908						
DS_ID:22679						
EP_NO: 16972						
Repair Type: Non-Urgent						
Crossing Status: Found						
UCIP Comments: Pump not found on the waterward side.Damaged pipe-plug on waterside. Pipe exposed on both sides of the levee.						
FIELD_STRUCT_DESC: 1 of 2: Two 8-inch pvc pipes (replaced two 8-inch steel pipes) through the levee, 2.0 feet below the crown. Siphon breaker on waterside. Pump on steel platform in drainage ditch. (App. No. 16972 - Joseph & Gayle Muller)						
FS Date: 10/31/2013

LS view: pump on steel platform over drainage ditch.

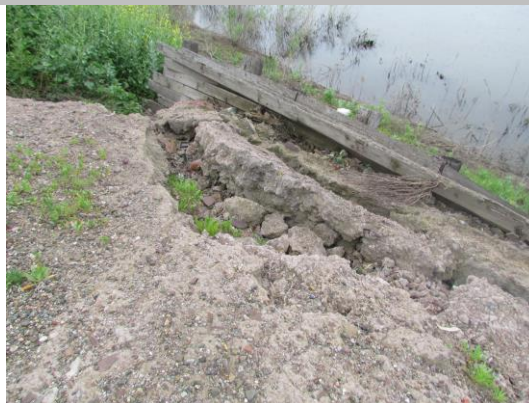
Photo 1 of 1 : SP_2017_RD0544_109_78_20170410_00094.jpg

LM Start	3.25	Rating **	U	Issue No.	78
LM End	3.25	Issue Type +	En	Location *	WS
Category	Earthen Levee			GPS Latitude/Longitude	
				Start	End
Item	Encroachments			37.819347 °	37.819347 °
				-121.360103 °	-121.360103 °
DWR ID	DWR_RD0544_02_s_2017_78				
Comment Code					
RW : Retaining Wall					
Inspector Comment					
Waterside slope retaining wall at pump location has slipped.

Looking east at sloughing of earthen pad on waterward shoulder and slope.

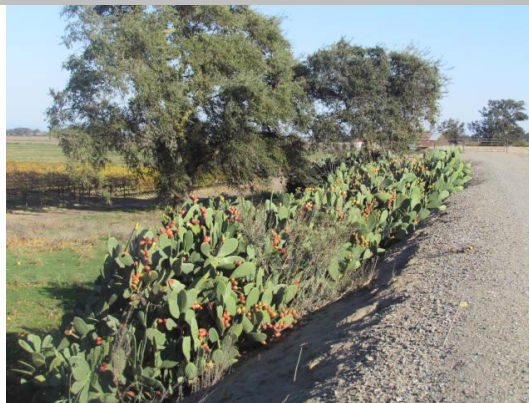
Photo 2 of 3 : SP_2017_RD0544_109_36_20170316_00032.jpg

LM Start	3.48	Rating **	U	Issue No.	36 (cont)	
LM End	3.51	Issue Type +	Ma	Location *	LS	
Category	Earthen Levee			GPS Latitude/Longitude		
				Start		End
Item	Vegetation			37.819576 °		37.819530 °
				-121.364056 °		-121.364653 °
DWR ID	DWR_RD0544_02_s_2012_36					
Comment Code						
V2 : Remove the wild growth other than native grasses from the levee slopes.						
Inspector Comment						
Cactus on landside slope.

Looking north at cactus on landside slope and toe spring 2015

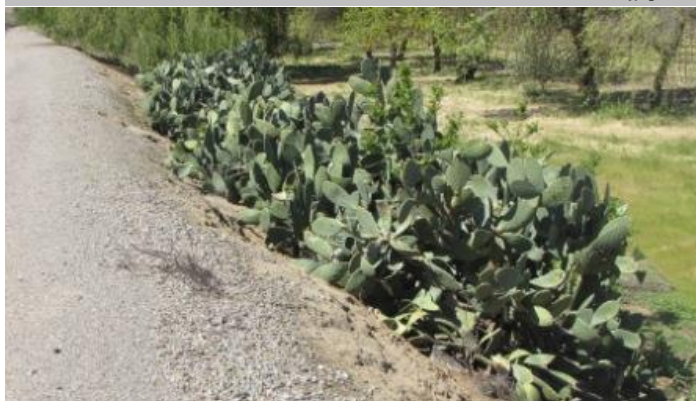
Photo 3 of 3 : SP_2017_RD0544_109_36_20170316_00033.jpg

Looking southwest at overgrown cactus on landside slope spring 2015.

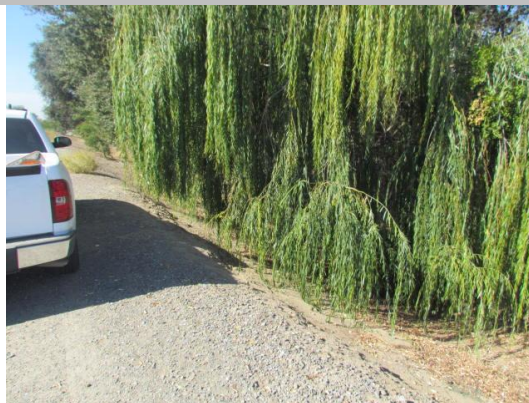
Photo 1 of 1 : SP_2017_RD0544_109_55_20170316_00044.jpg

LM Start	3.49	Rating **	U	Issue No.	55
LM End	3.52	Issue Type +	Ma	Location *	LS
Category	Earthen Levee			GPS Latitude/Longitude	
				Start	End
Item	Trim / Thin Trees			37.819563 °	37.819542 °
				-121.364307 °	-121.364908 °
DWR ID	DWR_RD0544_02_f_2014_55				
Comment Code					
T2 : Thin trees to allow visibility of the ground and room to flood fight.					
Inspector Comment

Looking southwest at untrimmed trees on landward slope and toe fall 2015.

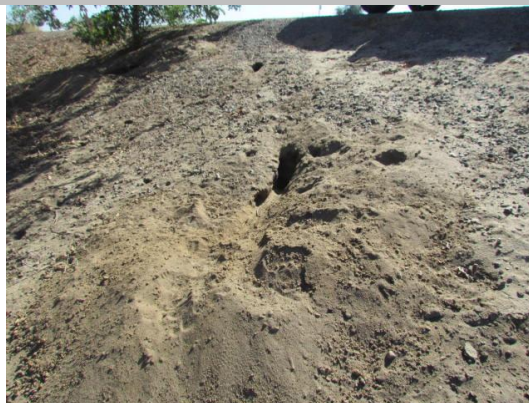
Photo 2 of 2 : SP_2017_RD0544_109_67_20170316_00053.jpg

LM Start	3.58	Rating **	U	Issue No.	67 (cont)	
LM End	3.58	Issue Type +	Ma	Location *	LS	
Category	Earthen Levee			GPS Latitude/Longitude		
				Start		End
Item	Animal Control			37.819419 °		37.819419 °
				-121.365854 °		-121.365854 °
DWR ID	DWR_RD0544_02_f_2015_67					
Comment Code						
A1 : Exterminate rodents and backfill and compact or grout burrows.						
Inspector Comment						
Large rodent holes on landward slope.

Looking north at typical view of rodent holes on landward slope.

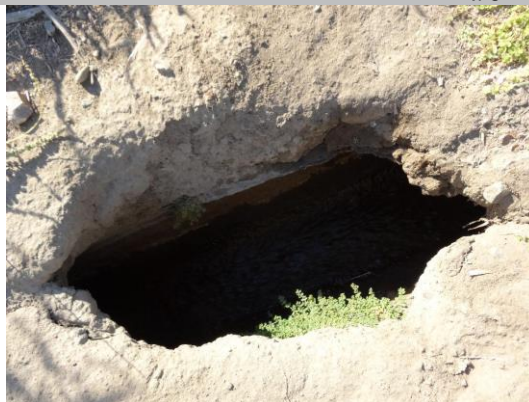
Photo 2 of 3 : UCIP_SP_2017_51375_43004.jpg

WS view: close view of levee slope with pits and holes.
